PERFORMANCE EVALUATION OF "FUSION™ BY BEMO USA CORPORATION" WALL ASSEMBLY FOR AIR INFILTRATION, WATER PENETRATION AND STRUCTURAL PERFORMANCE

Page 2 of 9 Report No. 18-06-B0180-BEMO1

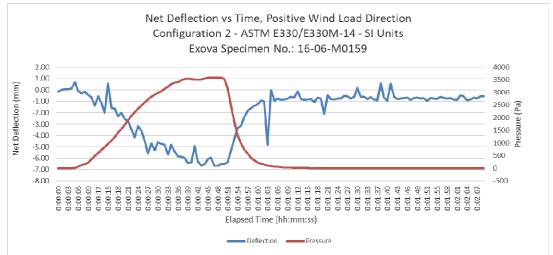
Figure No. 1 - Net Deflection vs Time, Positive Wind Direction, SI Units

Config	mmarized Structural Results, Positive Wind Load Direction guration 2 – ASTM E330/E330M-14 – SI & IP Units pecimen No.: 16-06-M0159 <i>(Test Date: June 23, 2016)</i>
	Gauge No. and Deflection

Gauge No. and Denection			
Pressure (Pa)	1	2	3	Net Deflection
3,591 Pa ⁽¹⁾	-1.5 mm	-8.5 mm	-2.0 mm	-6.7 mm
(75.0 lbs. /ft²)	(-0.059 inches)	(-0.333 inches)	(-0.080 inches)	(-0.263 inches)
Residual Deflection	-0.1 mm	-0.8 mm	-0.2 mm	-0.8 mm
	(-0.003 inches)	(-0.033 inches)	(-0.007 inches)	(-0.031 inches)

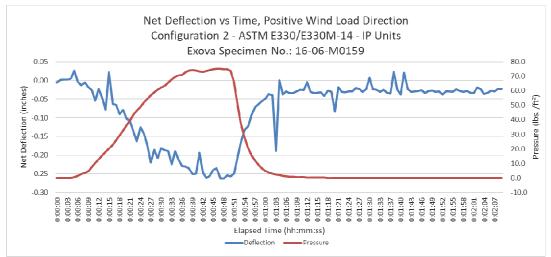
Figure No. 2 – Net Deflection vs Time, Positive Wind Direction, IP Units

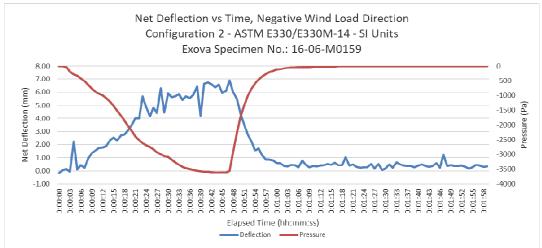
Figure No. 3 - Net Deflection vs Time, Negative Wind Direction, SI Units

Table No. 6 - Summarized Structural Results, Negative Wind Load Direction Configuration 2 – ASTM E330/E330M-14 – SI & IP Units Exova Specimen No.: 16-06-M0159 <i>(Test Date: June 23, 2016)</i>				
	Gauge No. and Deflection			
Pressure (Pa)	1	2	3	Net Deflection
3,591 Pa ⁽¹⁾ (75.0 lbs. /ft²)	1.0 mm (0.041 inches)	7.7 mm (0.302 inches)	2.4 mm (0.095 inches)	6.0 mm (0.234 inches)
Residual Deflection	0.1 mm (0.004 inches)	1.6 mm (0.006 inches)	0.3 mm (0.011 inches)	1.4 mm (0.056 inches)

Positive Loading Net Deflection Design Load: (+3591 Pa) = Negative Loading Net Deflection Design Load (-3591 Pa) =	<u>6.7 mm</u> < 13.6 mm Requirement <u>6.0 mm</u> < 13.6 mm Requirement
Positive Loading Net Deflection Design Load: $(+75.0 \text{ lbs. }/\text{ft}^2) = \text{Negative Loading Net Deflection Design Load }(-75.0 \text{ lbs. }/\text{ft}^2) =$	
⁽¹⁾ 3,591 Pa = 76.5 m/s (or 171 mph / 275 km/h).

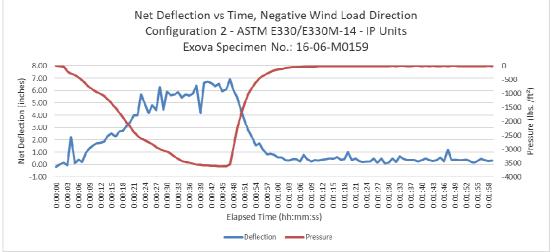
Figure No. 4 - Net Deflection vs Time, Negative Wind Direction, IP Units

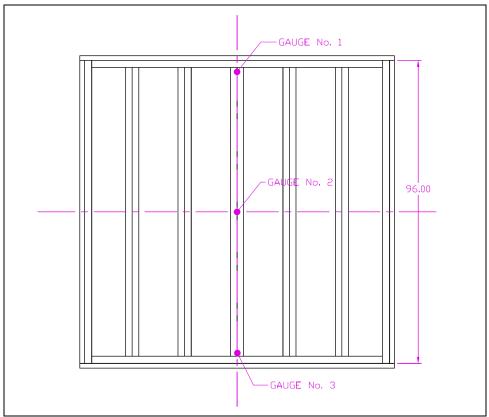
Note: Deflection measurement (gauge) locations employed during structural loading are shown below.

Figure No. 5 – Deflection Gauge Loactions

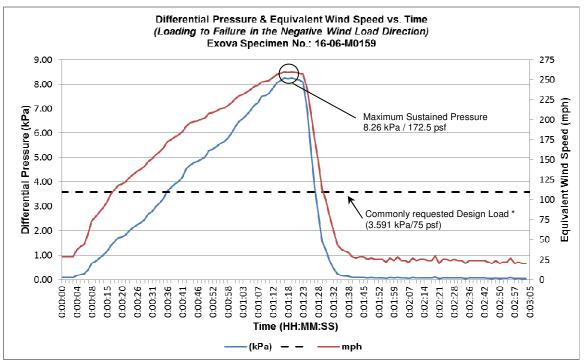
Figure No. 6 – Differential Pressure & Equivalent Wind Speed vs. Time (during testing to failure)

Table No. 7 - Summarized Structural Results Test to Failure in the Negative Wind Load Direction Configuration 2 – ASTM E330 – SI & IP Units Exova Specimen No.: 16-06-M0159 <i>(Test Date: June 24, 2016)</i>		
Maximum Pressure Achieved	Comments	
8,260 Pa ⁽²⁾	Cladding System did not disengage from wall assembly. However,	
172.5 lbs. /ft ²	vertical supporting steel studs buckled in the center

$^{(2)}$ 8,260 Pa = 116.1 m/s (or 260 mph / 418 km/h).

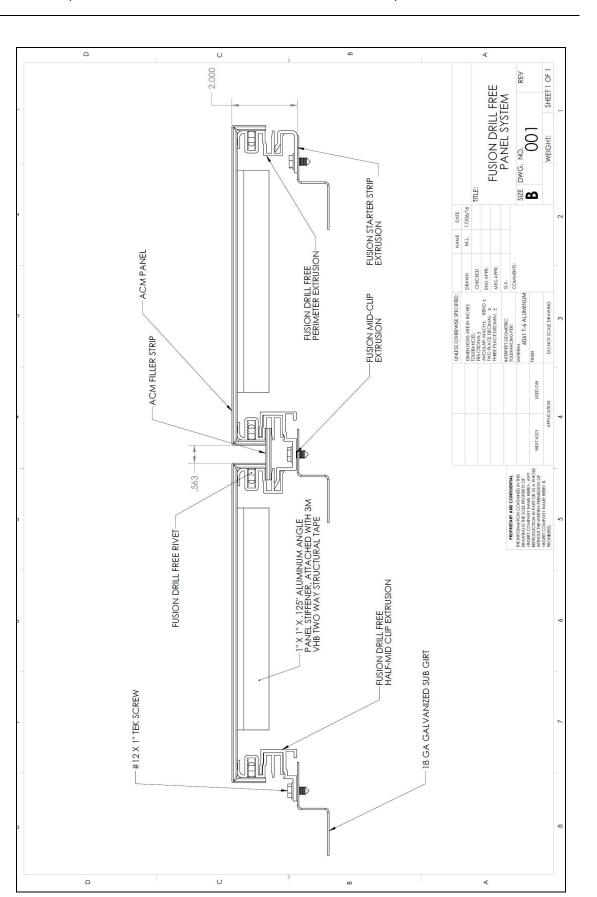
Appendix A, Page 2 of 2 Report No. 18-06-B0180-BEMO1

- 4 panels each 48" x 48"
- Each panel constructed with 4mm Larson ACM
- Rivets placed on maximum center distance of 16" between rivets.
- 3 weep holes per panel at .375" diameter with foam bug screen backing.
- All aluminum extrusion components are 6061 T-6 Aluminum, custom profiles
- Each panel perimeter is attached by Fusion Drill Free 3/16" rivets to Custom Fusion Drill Free perimeter extrusion (continuous around panel)
- 3" Long Mid-Clip Extrusion (Custom extruded Profile) located on 16" centers attached to panel perimeter extrusion and screwed to 18 GA galvanized sub-girts (G-90) with a 1" TEK screw.
- 2" Wide filler strip (4mm Larson ACM) used to cover the panel to panel joints
- Starter strip used on base of wall assembly.
- 3" Long Half Mid clips (custom extruded profile)used at top on termination condition to attach the panel to the galvanized sub girt.

Specimen Bill or Materials and Detailed Drawing as Provided by Carter Architectural Panels Inc.

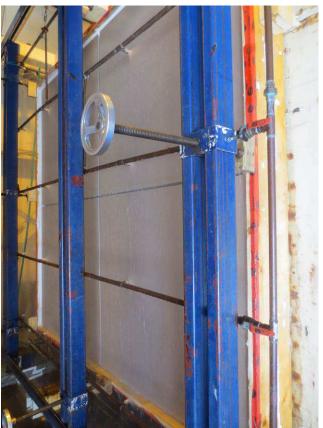
Figure B1 – Test Specimen (Exterior View)

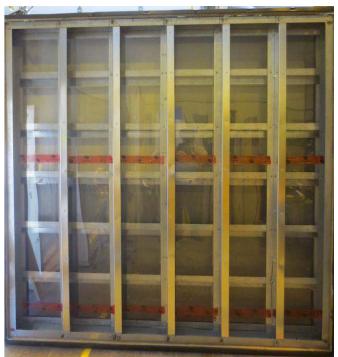
Figure B2 – Test Specimen (Interior View)
